CASE HISTORY

Clamp and Powerline Protection at Wind Power Transfer Station

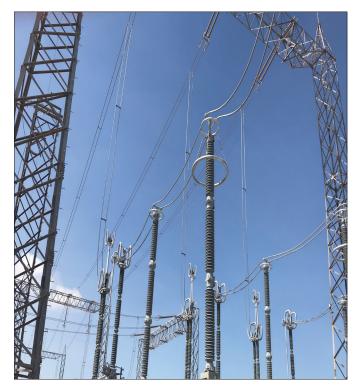
The clamps and areas around the clamps on the powerlines at a wind power transfer station were badly corroded not long after installation. This was due to the severe environment of the wind farm, which was located near the ocean in an area with strong wind and blowing sand.

The power was turned off at the transfer station before work started. The clamps were taken down and mechanically abraded to remove a majority of the corrosion. They were then cleaned using VpCI®-415, dried, and reinstalled (ElectriCorr® VpCI®-239 was also applied to the inside of most clamps before reinstallation). VpCI®-396 was applied as a primer coat and allowed to dry for two to three hours. VpCI®-384 was applied as a topcoat. In addition, the sections of wire on both sides of the clamps were coated with VpCI®-396 to protect the wire from further ingress of contaminants. Down below, VpCI®-368 corrosion inhibitors were applied to moving parts around the substation, and MCI®-2020 was applied to concrete support structures. MCI®-2005 was also added to a large sand containment wall at the wind farm for protection of the steel armature therein.
