CASE HISTORY

Long-Term Rust Prevention on Spare Marine Engine Crankshaft

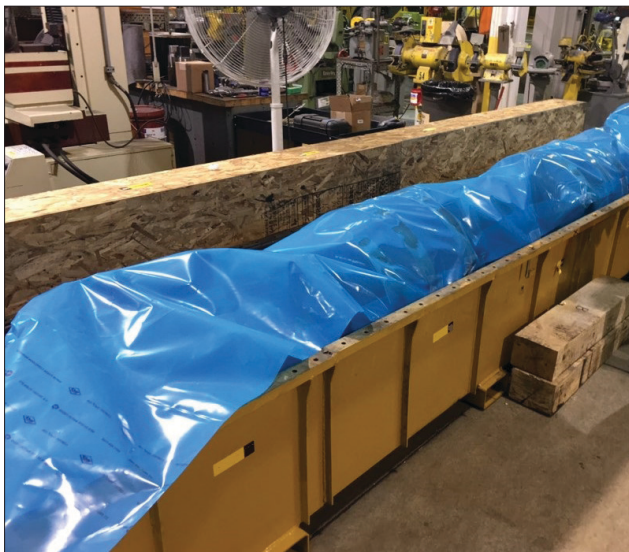
A large spare marine engine crankshaft needed to be preserved for up to 10 years of storage.

The crankshaft was cleaned with mineral spirits. Then VpCI®-369 was applied by brush to all surfaces and holes. A 10 mil (250 μ) piece of VpCI®-126 HP UV Shrink Film was cut and laid into a long, narrow metal storage box, with another narrow sheet of VpCI®-126 HP UV Shrink Film and a foam pad placed between the wooden bracing and the crankshaft for extra cushioning. BioPad® emitters were placed throughout the package as an additional source of VpCI® protection. Next, the VpCI®-369-coated crankshaft was lowered into the film-lined box. The film was wrapped around the crankshaft and all seams sealed using heat shrink tape. The upper film overlapped the lower film to create a watershed in case of moisture ingress.

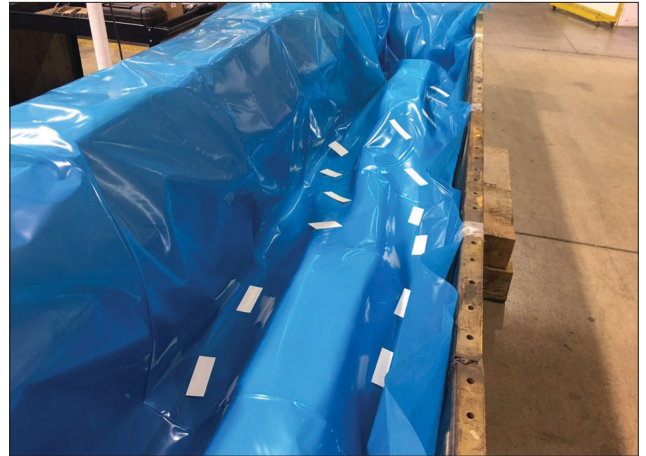
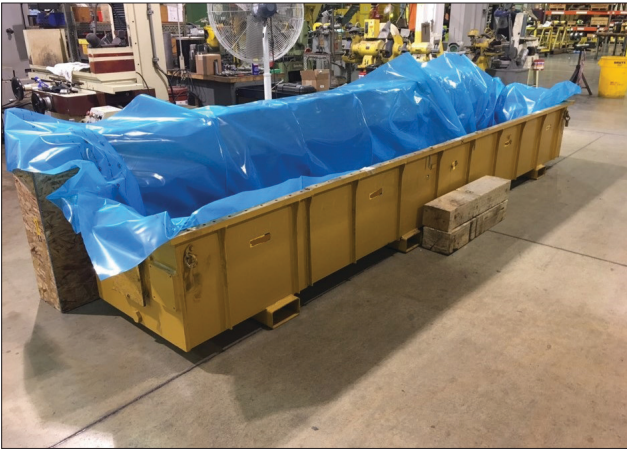
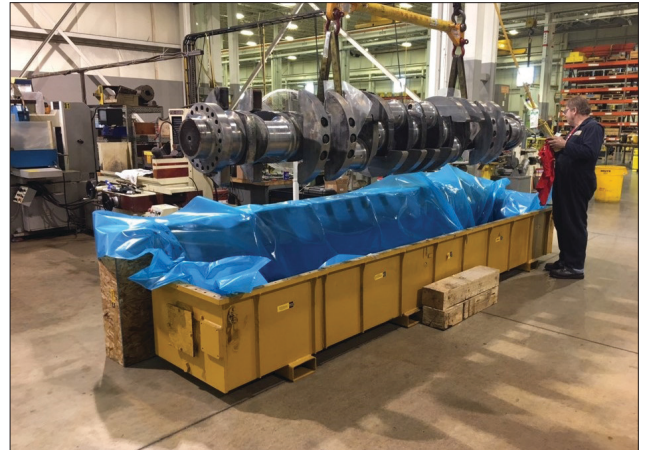
The customer was happy with the preservation and shipped the spare part to a dealership on the east coast. Sealed tightly in its box with a variety of Cortec® preservation materials, the crankshaft was well-equipped to be safely stored either indoors or outdoors for many years until needed as a spare.
