CASE HISTORY

Pipe Preservation Alternative to Nitrogen Blanketing

Oil & Gas Company

VpCI®-337
VCI/VpCI® Vapor Detection Test Kit™

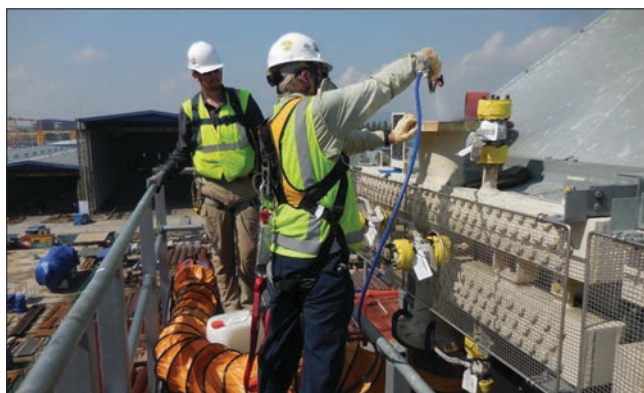
VpCI®-337 fogging fluid was dosed according to the volume of all tube sections and the void space of the inlet/outlet header box. An enclosure was created around the inlet for fogging that allowed minimal air loss (not airtight) while still ensuring manipulation of the fogging nozzle, tip, and mechanism. Half of the full dosage of VpCI®-337 was fogged into the inlet until any visible fog was seen emitting from the exhaust outlet or the VCI/VpCI® Vapor Detection Test Kit™ indicator strip changed color. The remaining dosage was subsequently applied, and the system was sealed.

VpCI®-337 proved to be a good substitute for nitrogen blanketing and provided 24 months of protection for the equipment.
